Towards nZEB buildings: a historical building case study

The recast of EU Directive 2010/31 introduced the concept of (nearly) zero energy building (NZEB). In Italy this challenge is remarkable: existing buildings stock (mainly residential) is also historic, so it's subject to environmental constraints or architectural-artistic value. A case study of a radical refurbishment with NZEB as target is Ca' S. Orsola in Treviso.

The case study

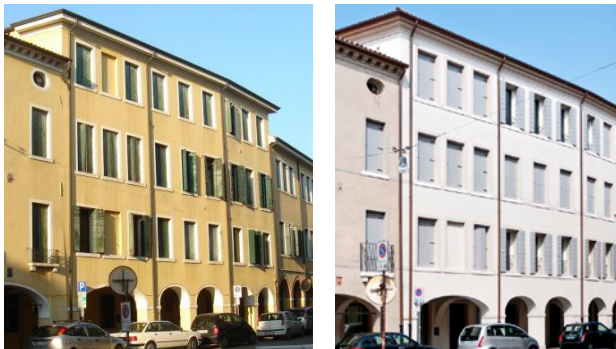
Figure 1. General view of the building before (left) and after the intervention (right).

The building was inhabited until 2000 and during the time it kept intact the original structure and architectural distribution. Then it was bought in 2007 for acting a deeply renovation and converting it in a prestigious residential building; this renovation has been completed in 2012. The whole building (**Figure 1**) is a gross volume of 6 300 m³ and an area of 4 500 m².

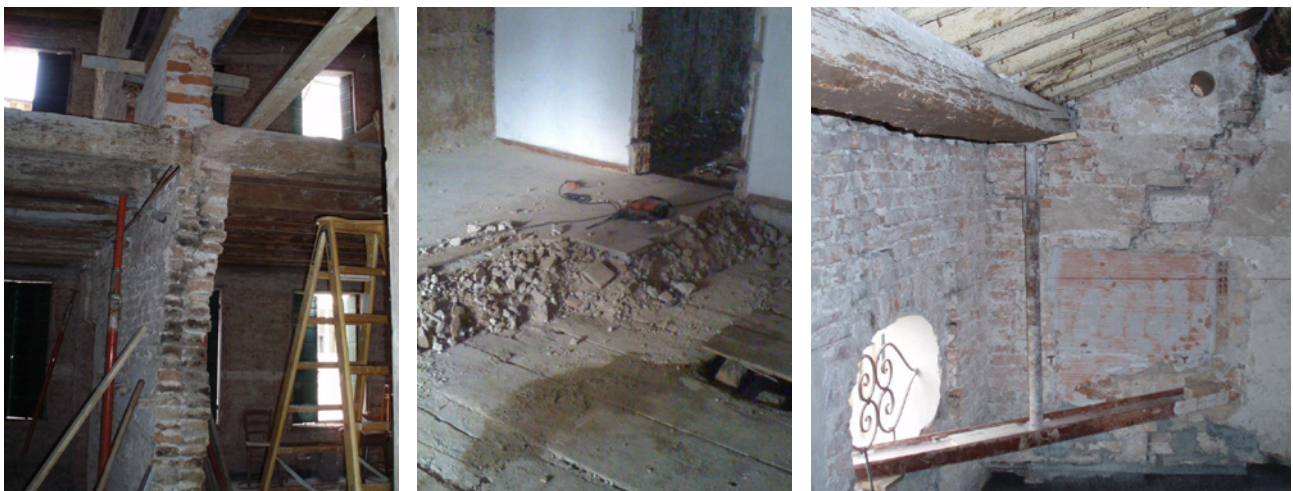
Figure 2. Building envelope before renovation: crooked walls (left), demolished partition walls left and used as a substrate (center), beam support in the perimeter wall (right).

At the beginning of construction phase the structure revealed a quite ruined state of conservation: walls are crooked and presented different solutions, moisture affected wooden elements in the floors and in the roof. There was a heritage architectural restriction about the external envelope. Specific goals of renovation project were:

Building envelope before renovation presented a traditional construction system, based on bearing masonry with covered solid bricks. The floor had a wooden structure, while the ground floor leaned directly on soil. The roof is made of hollow tiles sheets with a wooden structure and a lightweight ceiling slab (Figure 2).

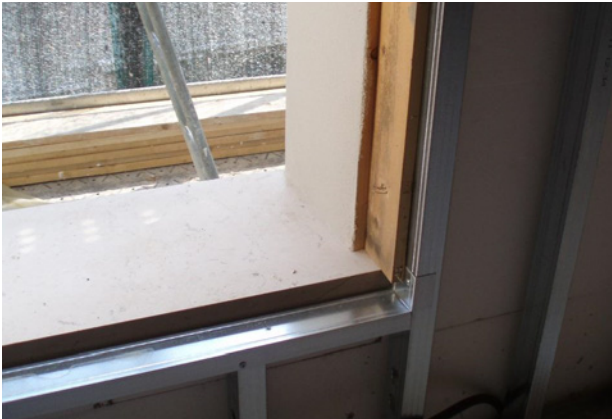
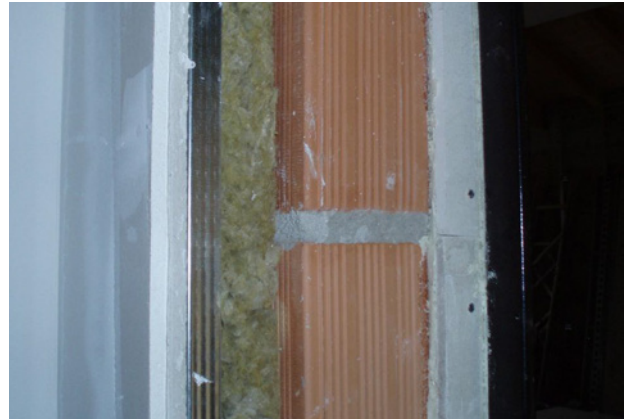
Figure 3. Insulation on internal (left) and external walls (right).

In the external walls the insulation is placed on the inner part (Figure 3) and this solution meet the requirements of the Superintendence of Veneto Region, preserving the existing materials and the external architectural identity of the building. Specifically, two types of insulating are used: an expanded polystyrene (EPS) foam, placed directly on masonry, and a rigid mineral wool panel with a plasterboard cover. Roof was replaced with a new wooden structure and it was insulated with wood fibre and water tight covering. All existing windows are replaced with a low-energy double layer ones within wooden frames.

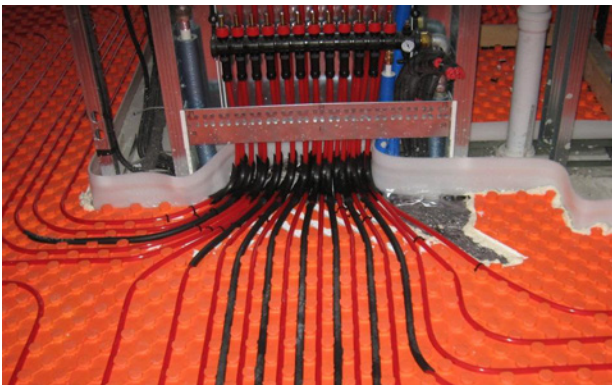
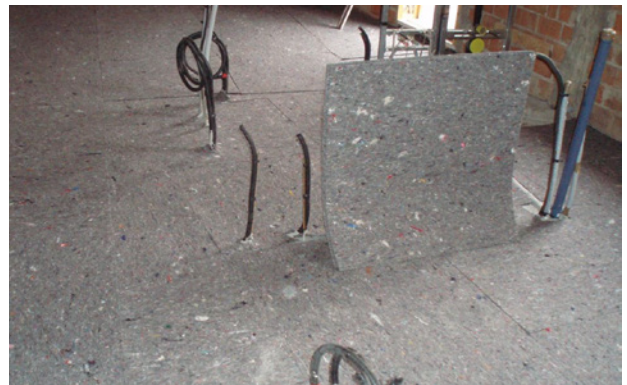
Figure 4. Radiant system: collectors (left) and TNT underflooring above system (right).

About technical systems, the HVAC generation system is a water to water centralized heat pump/chiller. The underlying well is the hot/cold water source and internal comfort is achieved exploiting a radiant system (Figure 4) installed in the floor together with a dehumidification system for the summer period.

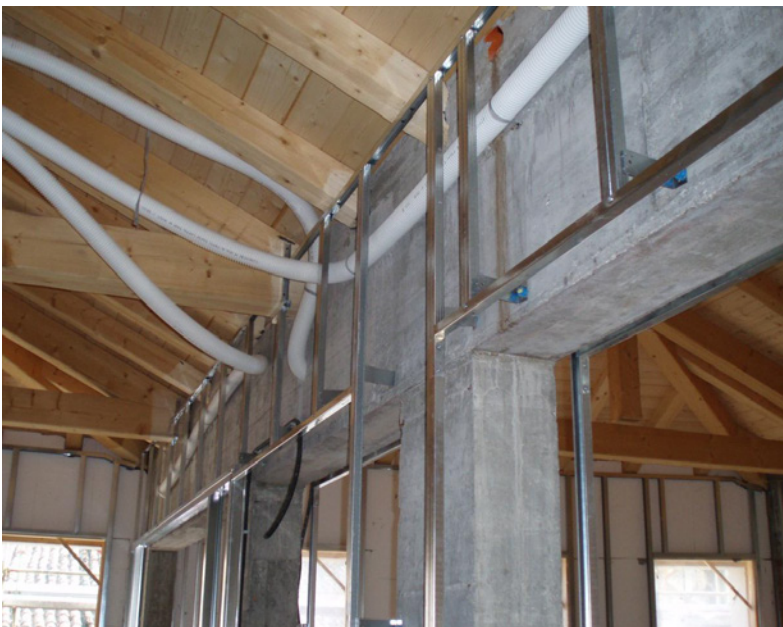
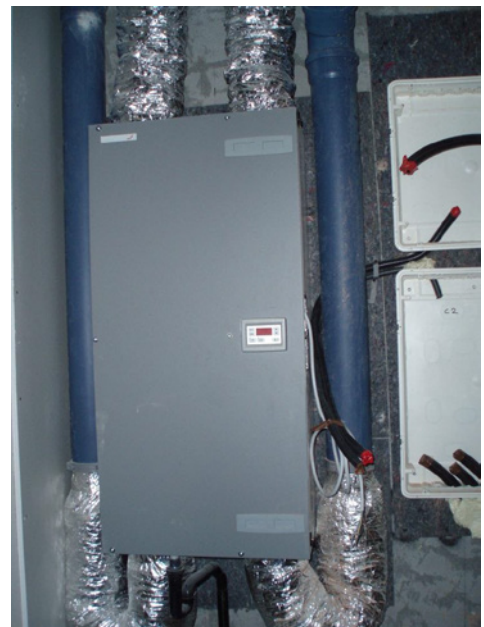
Figure 5. Mechanical ventilation system: ducts and Heat Recovery.

For heating and cooling the system adopted is a 32 kW heat pump with a distribution by radiant floor system; another heat pump (20 kW) is installed for domestic hot water requirement (DHW); mechanical ventilation (Figure 5) is provided by a system with heat recovery box (95% efficiency).
